Testing and repair instructions with test specifications for Saab 9000/9000 Turbo (1984→) with air conditioner.

Air conditioner control unit is equipped with self-diagnosis.

3. Electrical terminal diagram of air conditioner

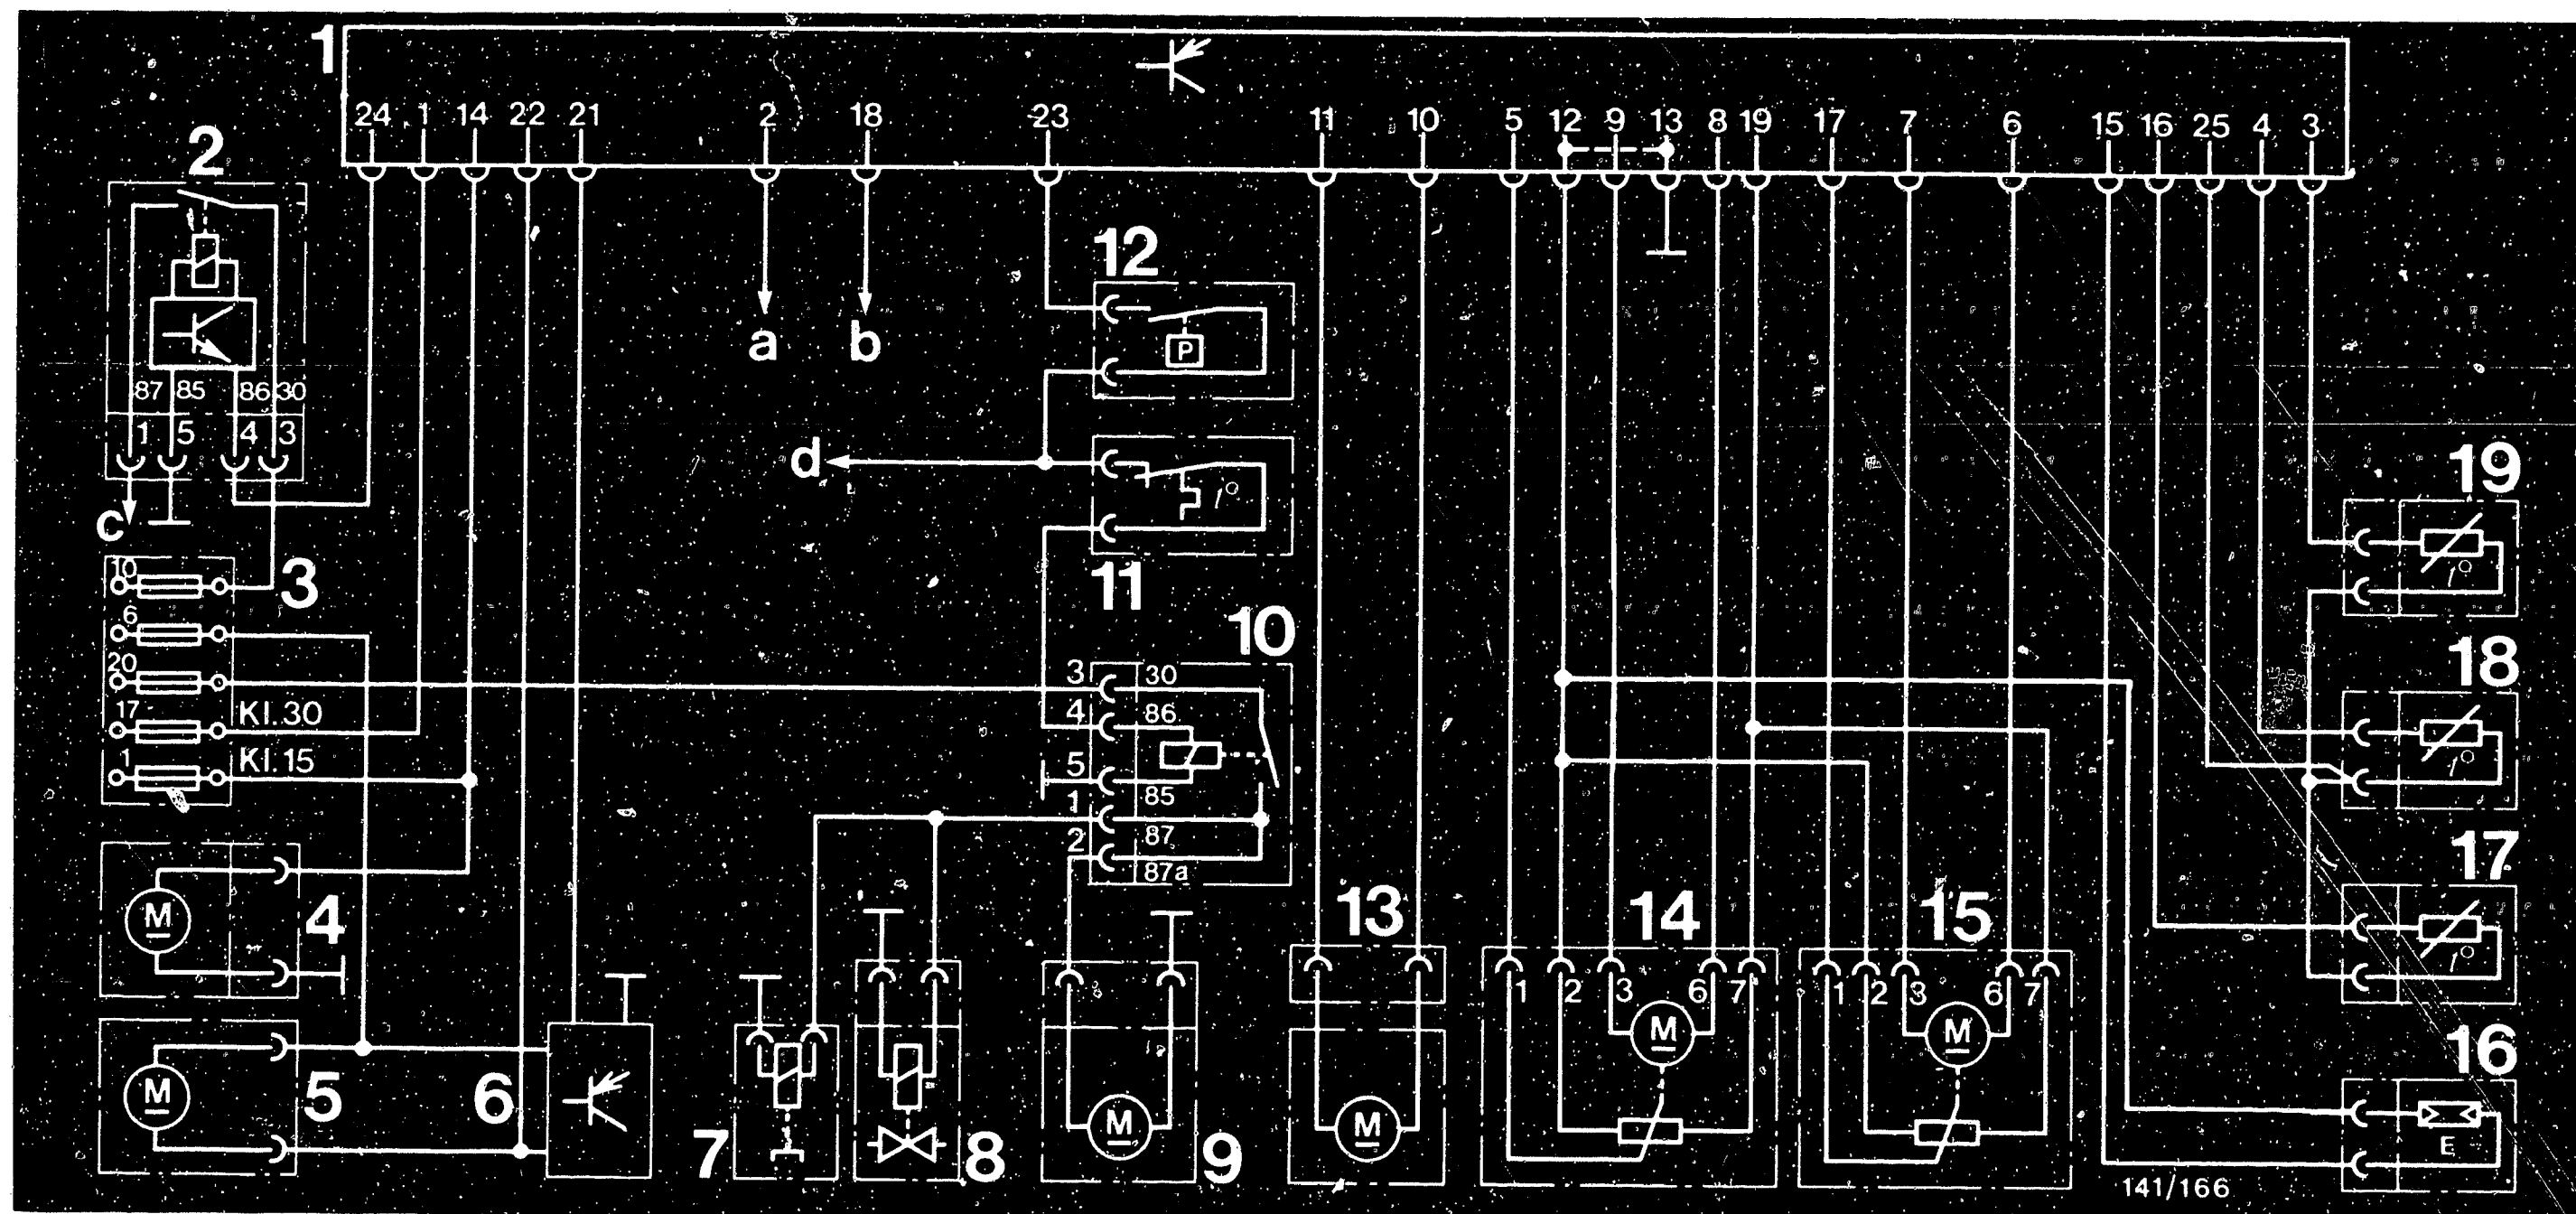
- 1 = Electronic control unit with control panel  
 2 = Heated rear window relay  
 3 = Fuse box  
 4 = Suction blower for passenger-compartment temperature sensor  
 5 = Blower motor  
 6 = Solar sensor  
 7 = Solenoid-operated valve for idle increase  
 8 = Refrigerant compressor magnetic clutch  
 9 = Engine fan

- 10 = Refrigerant compressor relay  
 11 = Icing protection switch  
 12 = Refrigerant compressor pressure switch  
 13 = Fresh/recirculated air flap drive  
 14 = Air distributor flap drive  
 15 = Mixing flap drive  
 16 = Solar sensor  
 17 = Outside temperature sensor

- 18 = Blow-in temperature sensor  
 19 = Passenger-compartment temperature sensor

- a = to light switch  
 b = to instrument illumination brightness control  
 c = to heated rear window and outside-mirror heating  
 d = to AC cooling blower relay

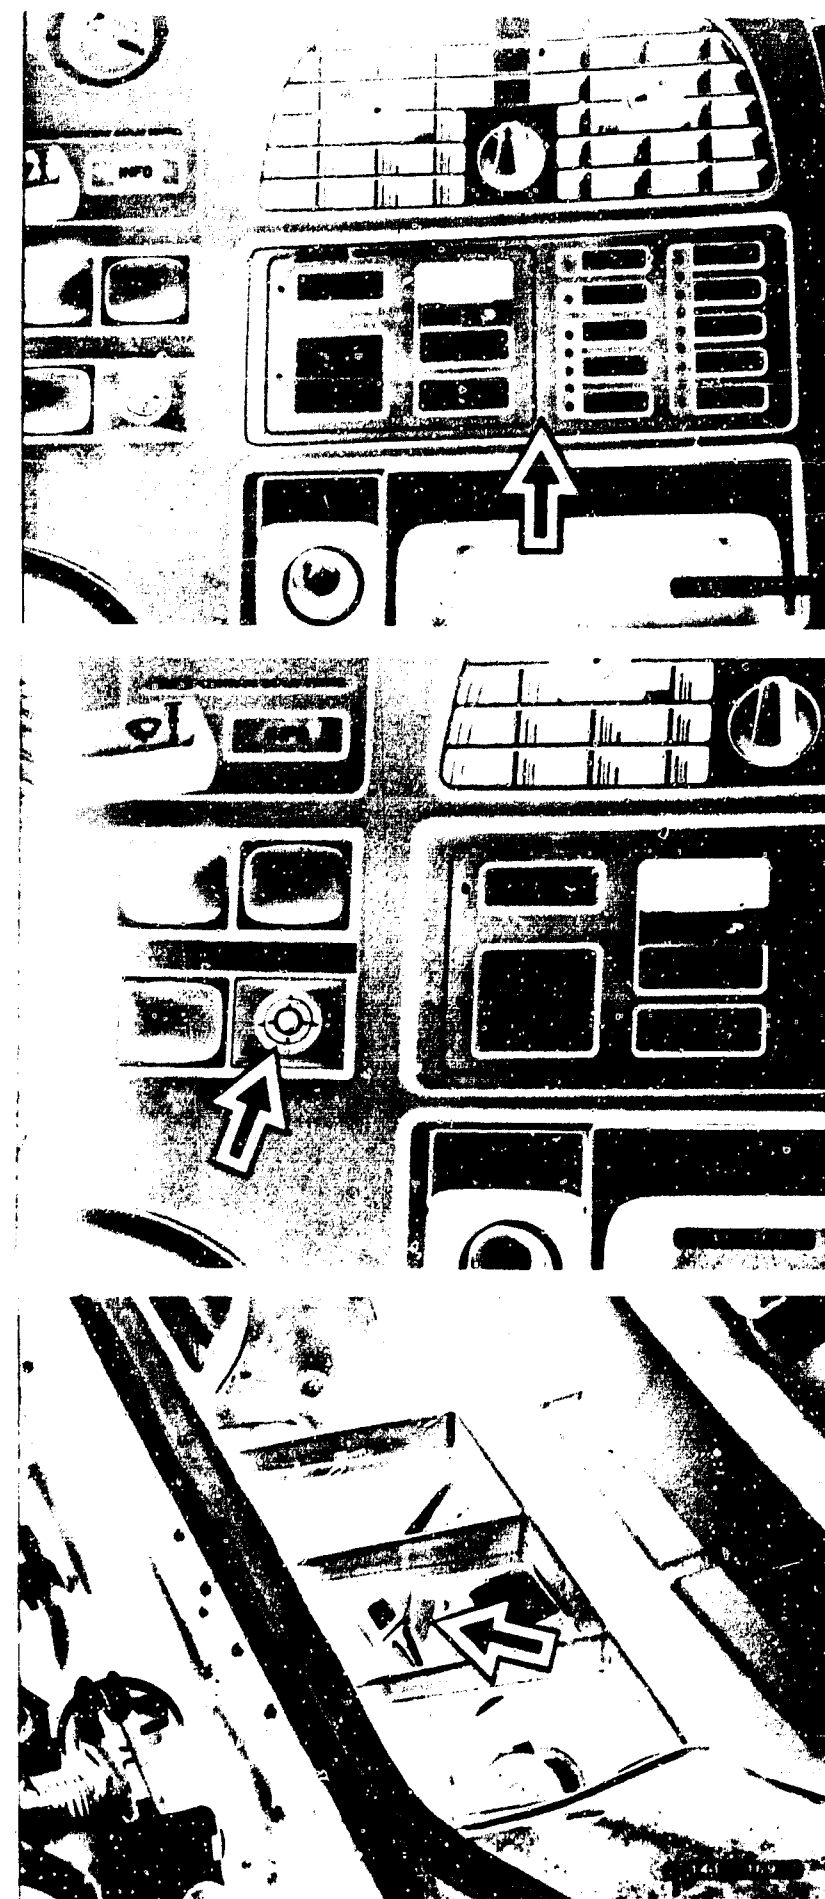
Control panel with built-in control unit is installed in the center console (see top picture). To remove, take out ashtray and press control unit out of holding clamps from rear.

Passenger-compartment temperature sensor is mounted in the dashboard next to the control panel (see center picture, arrow). Air is admitted to the passenger-compartment temperature sensor by a suction blower (installed behind glove compartment on servo motor unit).

Outside-temperature sensor is screwed onto the blower box on the outside (see bottom picture, arrow).

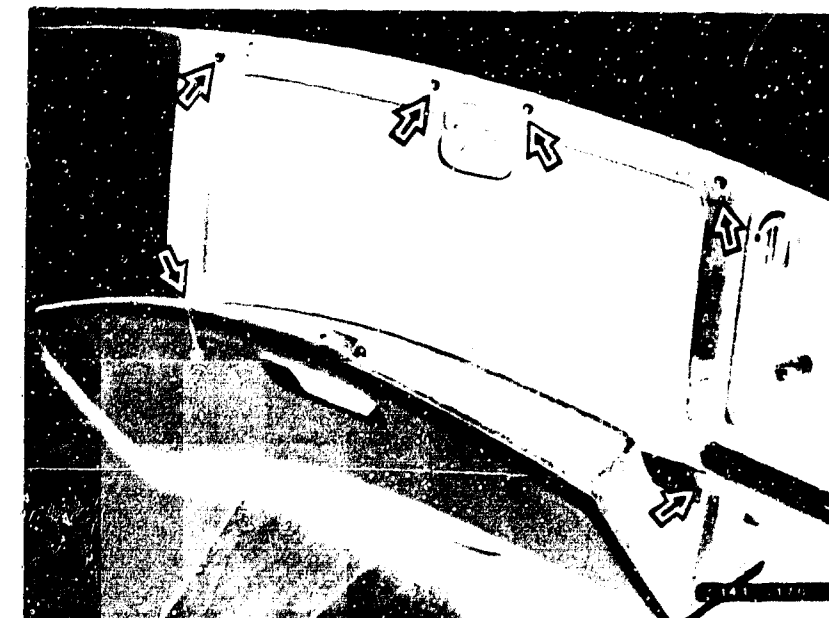
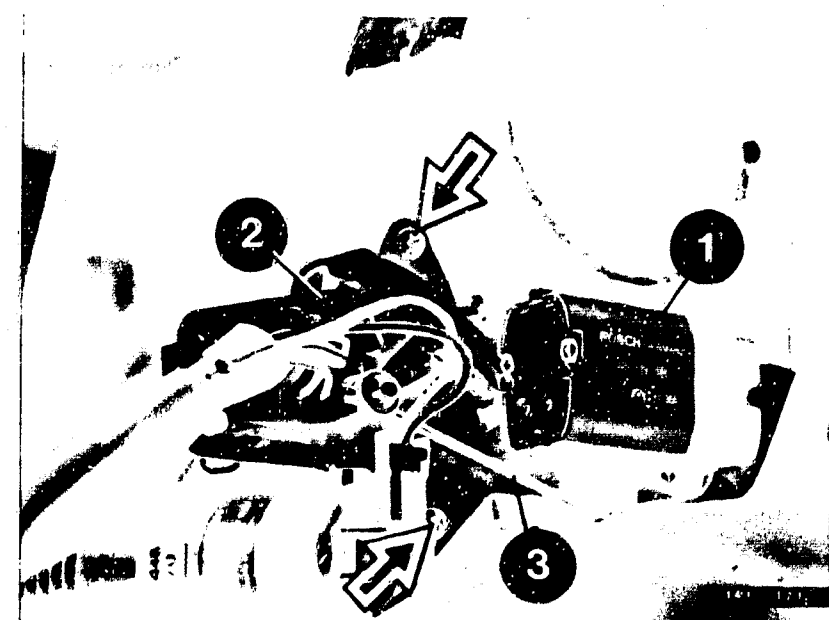
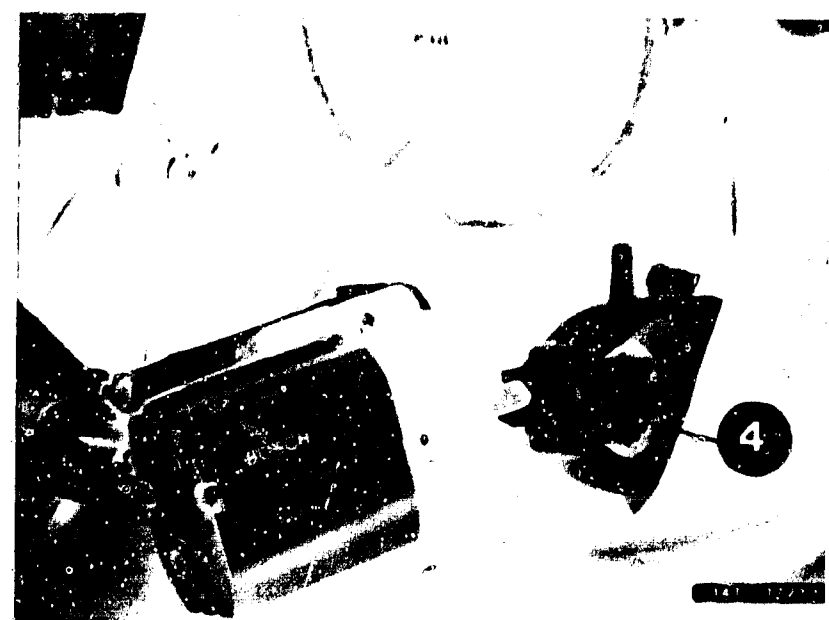
The flap control unit consists of air distributor flap drive (center picture "1") and mixing flap drive (see center picture "2"). The flap control unit is mounted on the heater box under the glove compartment. To remove/install, take out glove compartment and central-electrics box. For glove-compartment fastening screws, see top picture, arrows.

The flap control unit is mounted on the heater box by 2 screws (center picture, arrows). The mixer flap is adjusted by the cable "3" (see center picture), the air distributor flap by the servo drive "4" (see bottom picture).

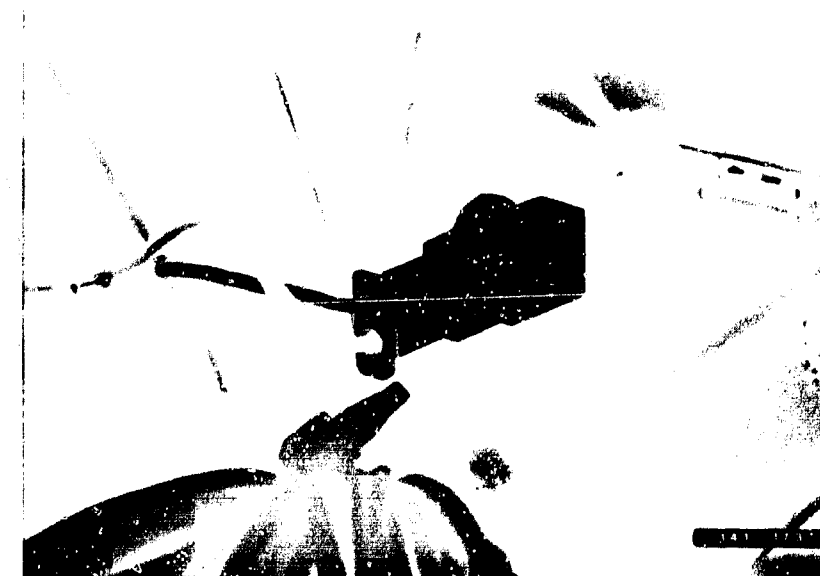
The blow-in temperature sensor is clipped into the heater box below the flap control unit (see top picture).

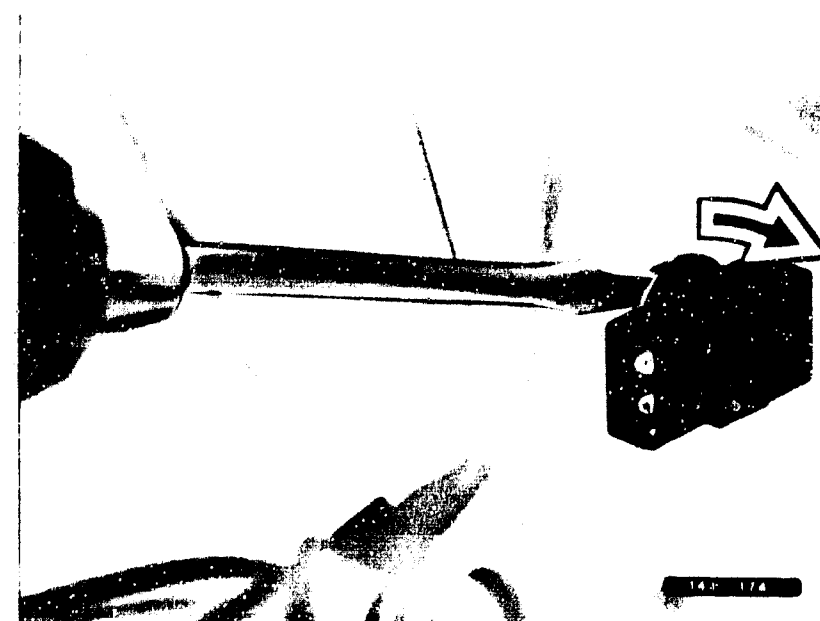
To remove, apply screwdriver between blow-in temperature sensor and heater box and press out blow-in temperature sensor (see center picture).

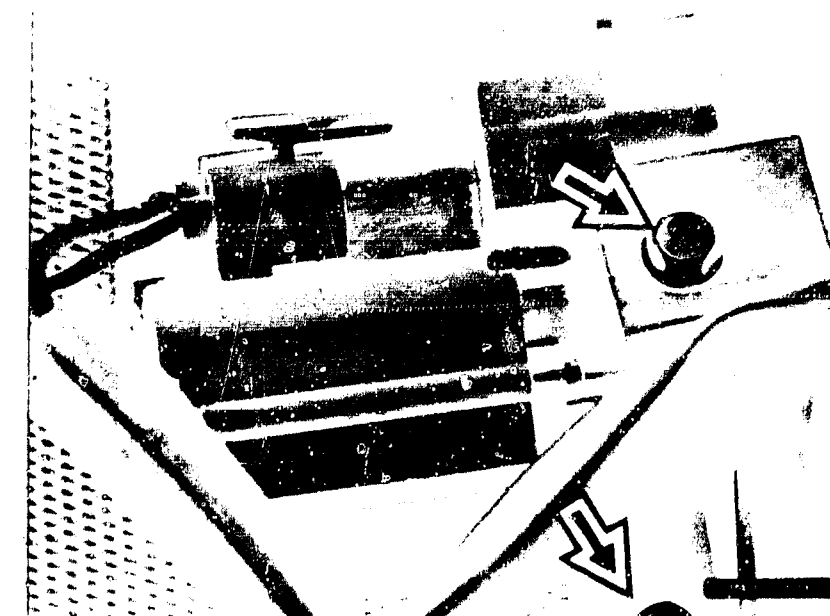
The fresh/recirculated air flap drive is installed in the engine compartment on the right under the cover (already removed in picture). To remove/install, unscrew fastening screws (see top picture, arrows) and withdraw drive from fresh/recirculated air flap.

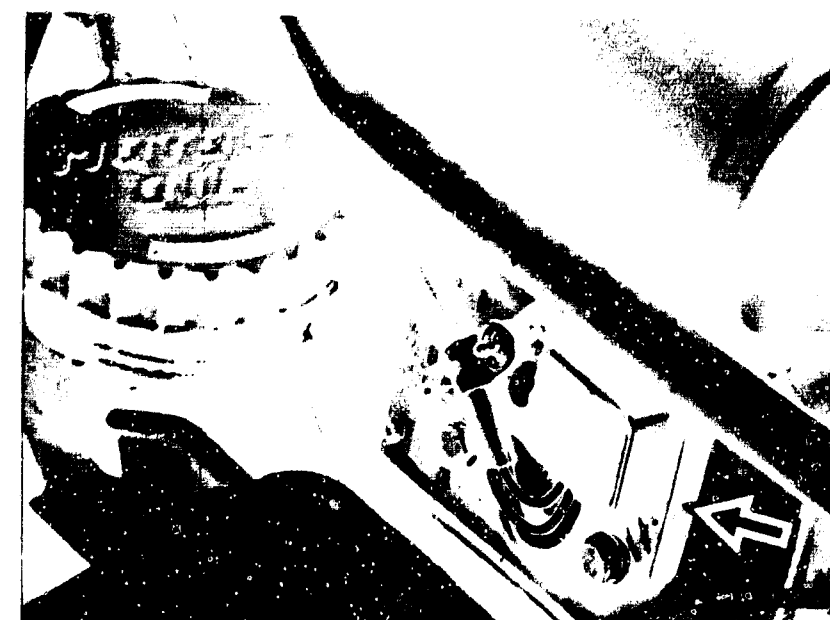
The blower controller with heat sink is mounted on the evaporator housing behind the intermediate wall (see center picture, arrow). To remove/install, take out the intermediate wall (already removed in picture).

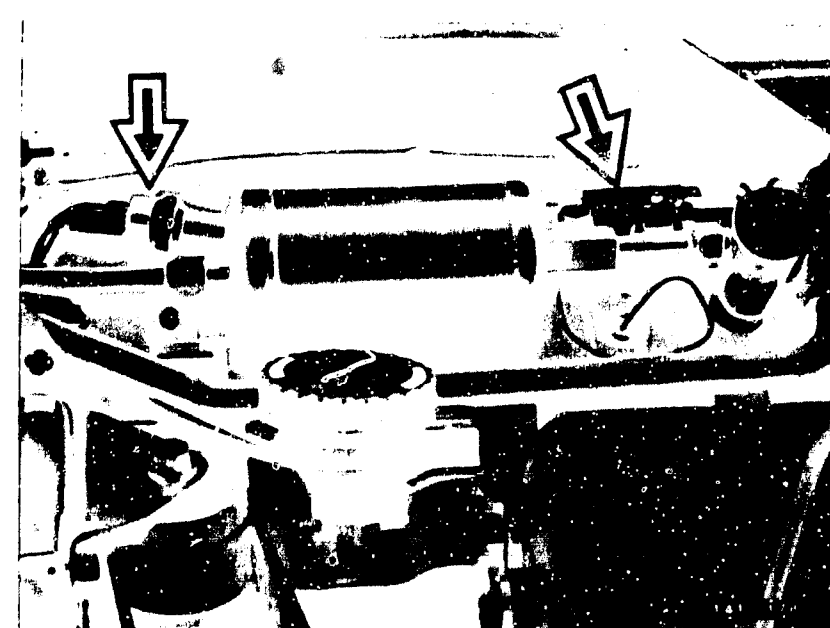
Pressure and icing-protection switches are installed in the engine compartment under the cover (already removed in picture) (see bottom picture).

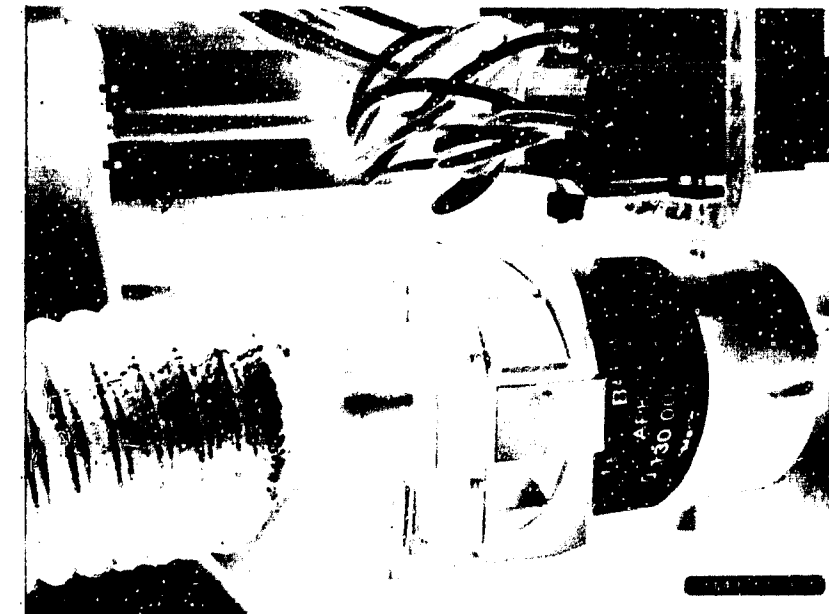
The suction blower for admitting air to the passenger-compartment temperature sensor is mounted on the flap control unit behind the glove compartment (see top picture).

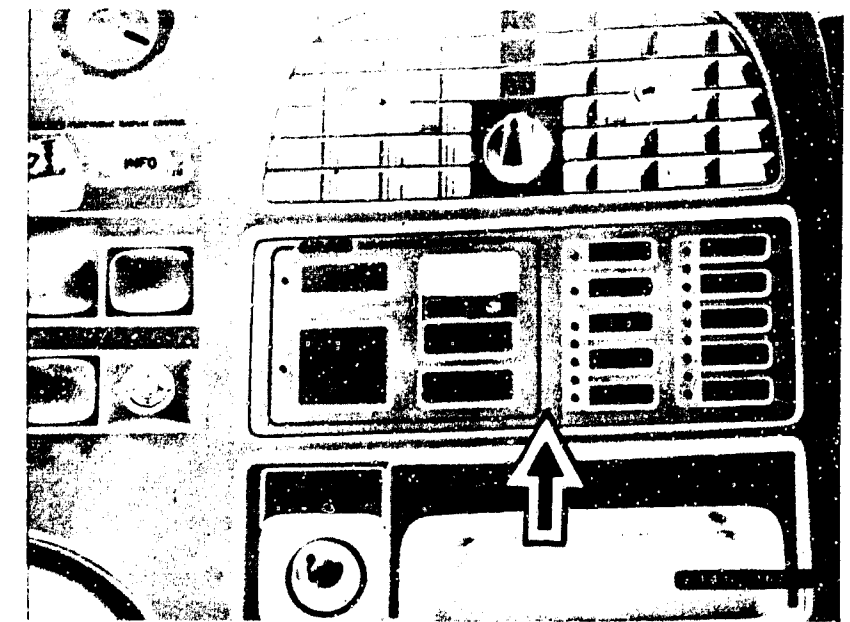
Simultaneously press "AUTO" and "VENT" keys, then release "AUTO" key first. All segments of display flash. After the self-diagnosis has been run through, the display shows the number of faults detected in the system.

By pressing the "VENT" key it is possible to have the individual faults displayed one after the other.

After the last fault has been displayed, pressing the "VENT" key again returns the control unit to its normal operating program.

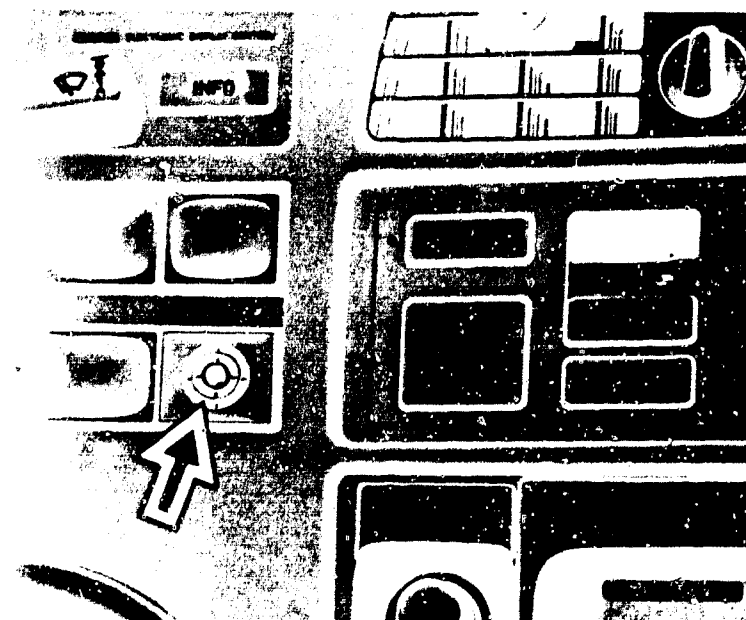
- check resistance of passenger-compartment temperature sensor between pins of passenger-compartment temperature sensor:

Reading should be: 16 ... 8 k $\Omega$   
at approx. 15°...30°C  
at passenger-compartment temperature sensor.

Arrow = Passenger-compartment temperature sensor

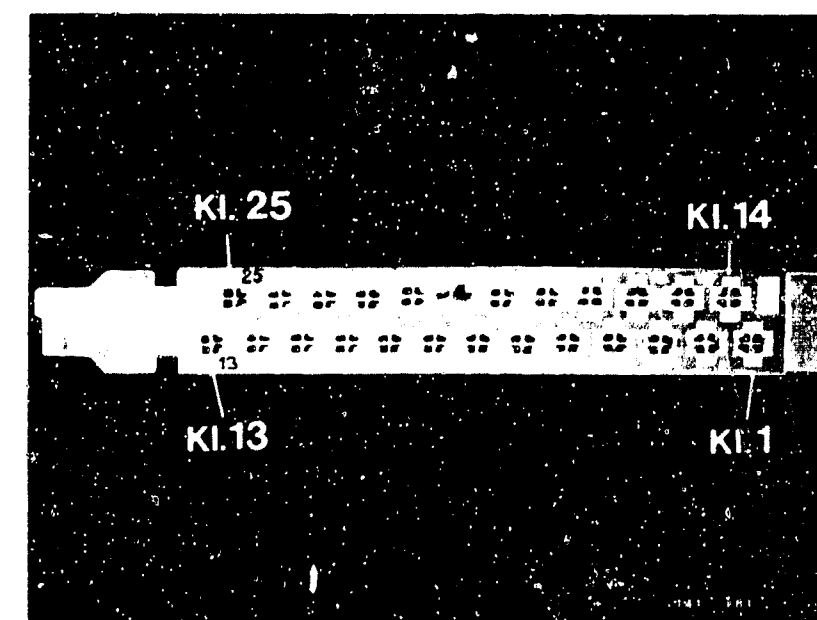
Control unit plug

Using ohmmeter, check term. 3 to term. 25 on control unit plug.

- from control unit plug term. 3 to temperature sensor plug
- from control unit plug term. 25 to temperature sensor plug

- check term. 3 to term. 25 on control unit plug (temperature sensor plug disconnected)

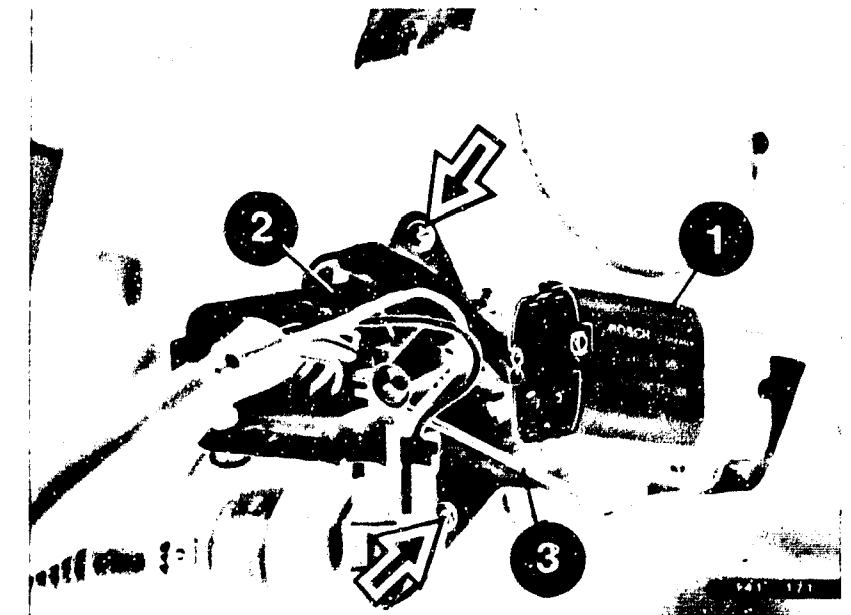
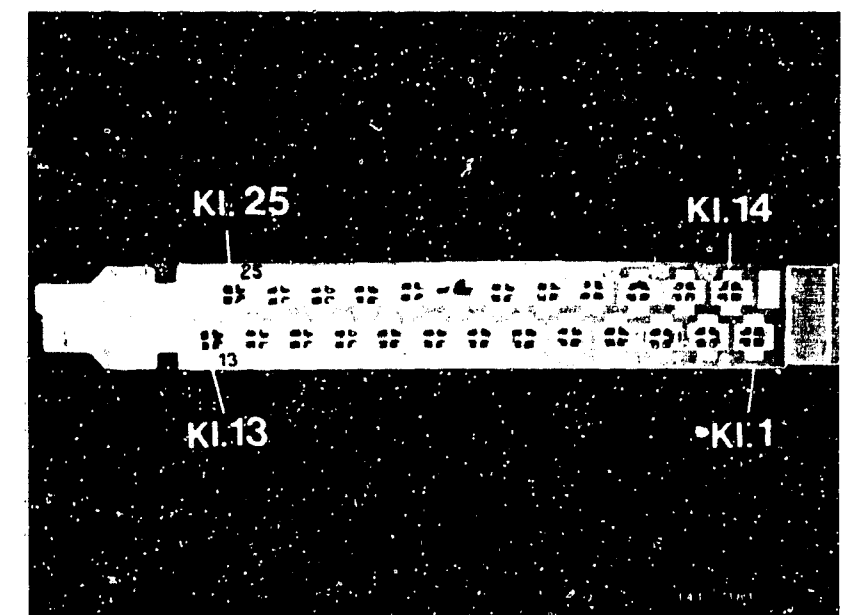
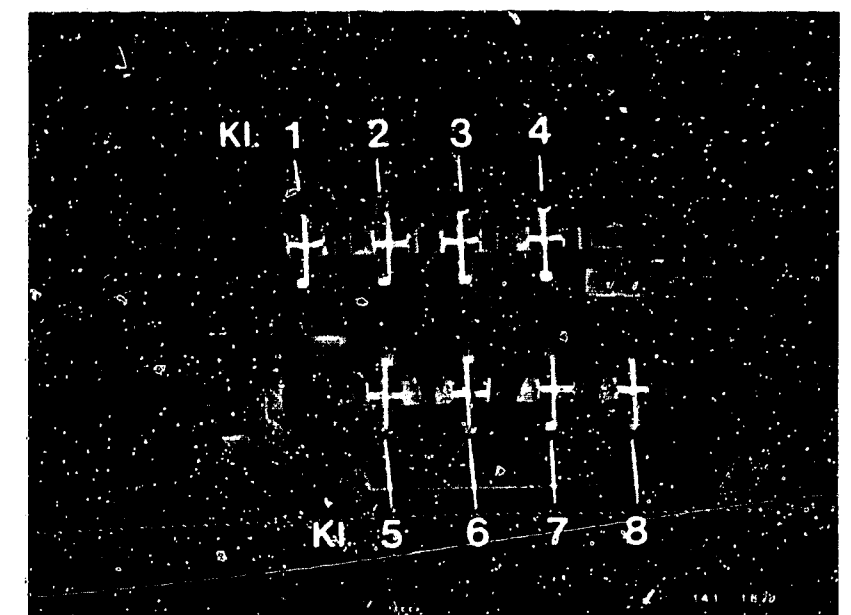
- from control unit plug term. 6 to plug of mixing flap drive term. 5 (see bottom picture)
- from control unit plug term. 7 to plug of mixing flap drive term. 8

- from control unit plug term. 19 to plug of mixing flap drive term. 6 (see bottom picture)
- from control unit plug term. 12 to plug of mixing flap drive term. 3

- term. 19 to term. 12 on control unit plug (plug of flap control unit (bottom picture) disconnected).

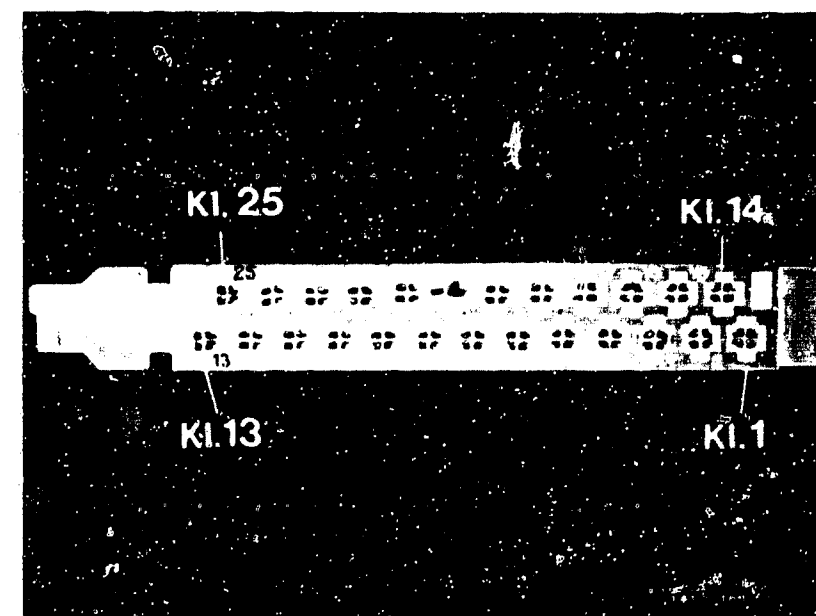
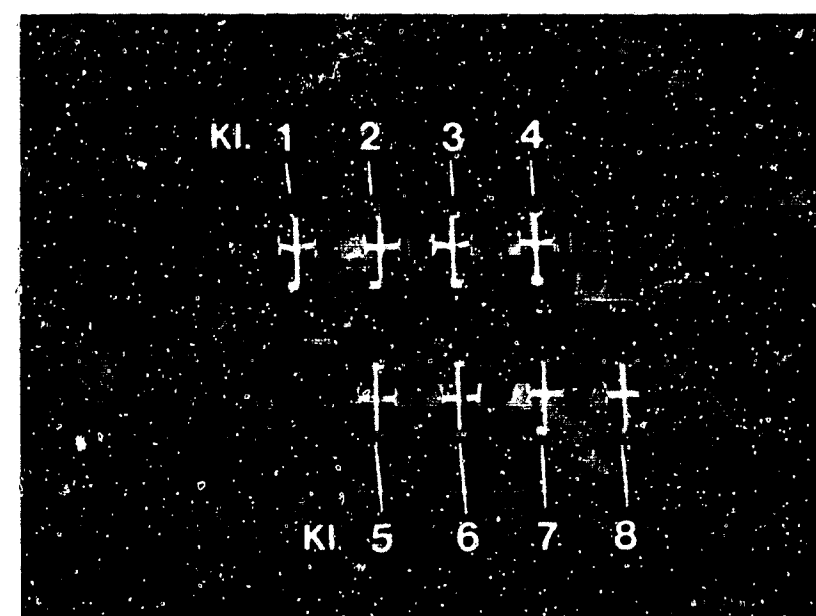
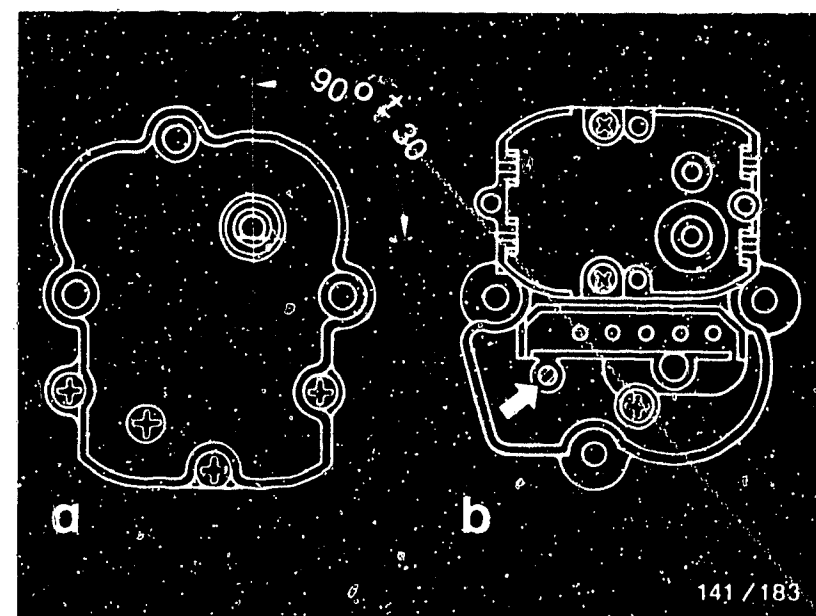
- from control unit plug term. 17 to plug of  
flap unit term. 7 (see center picture)

If, when removed, the mixing flap servo motor  
was operated, check adjustment of feedback  
potentiometer. To do this, let motor run to  
position shown, see bottom picture "a".

Apply 13 V voltage source to plug of flap  
control unit term. 6 (+) and term. 3 (-).

Connect voltmeter to term. 7 and term. 3.

Adjust voltage 6.4...6.8 V at potentiometer  
shaft (see bottom picture "b", arrow).

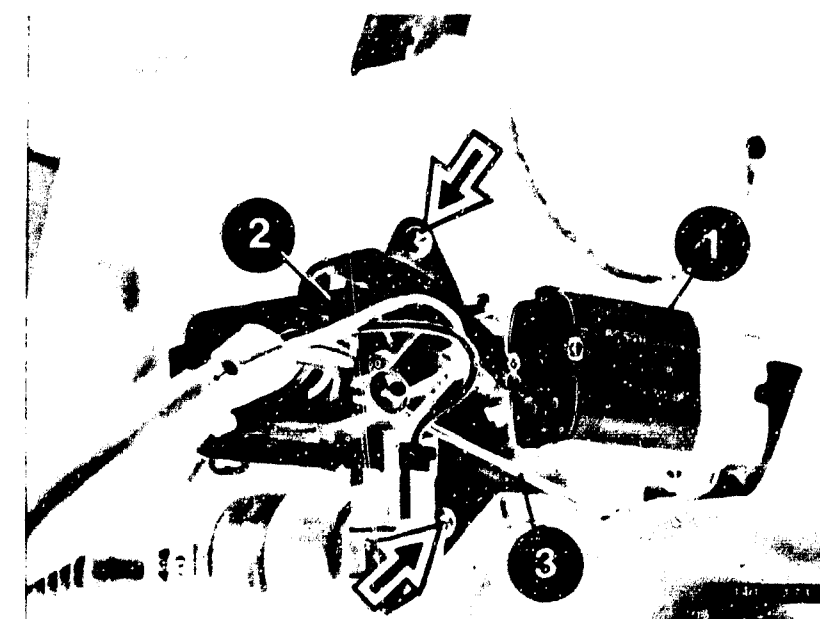
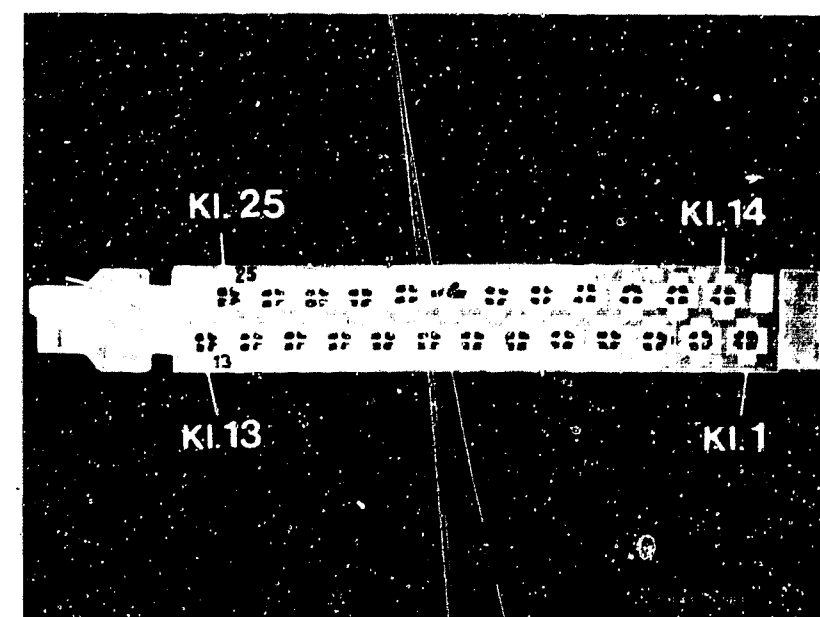
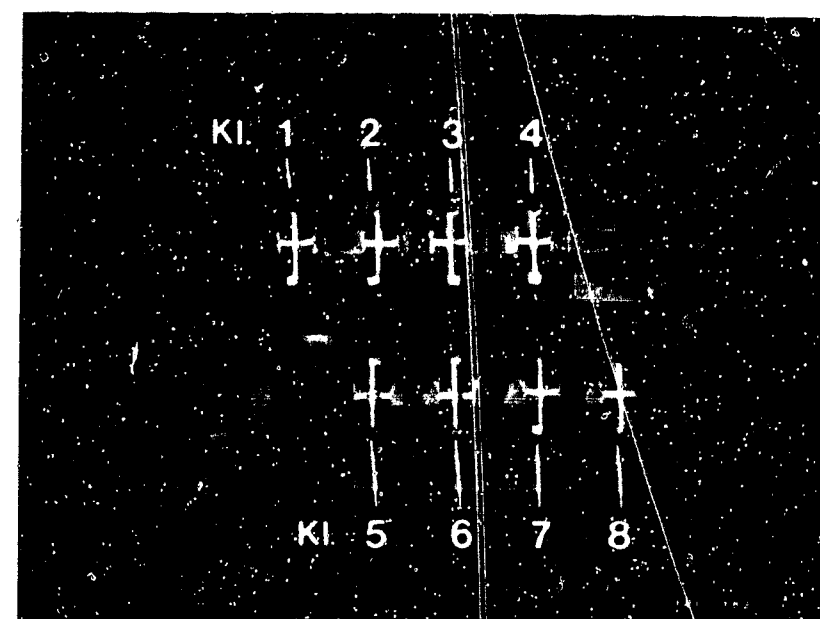
- from control unit plug term. 8 (see center picture) to plug of air distributor flap drive term. 4 (see bottom picture)
- from control unit plug term. 9 to plug of air distributor flap drive term. 1  
reading should be:  $0 \Omega$
- term. 8 to term. 9 on control unit plug  
reading should be:  $\infty \Omega$   
(plug of air distributor flap drive disconnected).

- from control unit plug term. 19 (see center picture) to plug of air distributor flap drive term. 6 (see bottom picture)
- from control unit plug term. 12 to plug of air distributor flap drive term. 3  
reading should be:  $0 \Omega$
- term. 19 to term. 12 on control unit plug  
(plugs of air distributor flap drive and mixing flap drive disconnected).  
Reading should be:  $\infty \Omega$

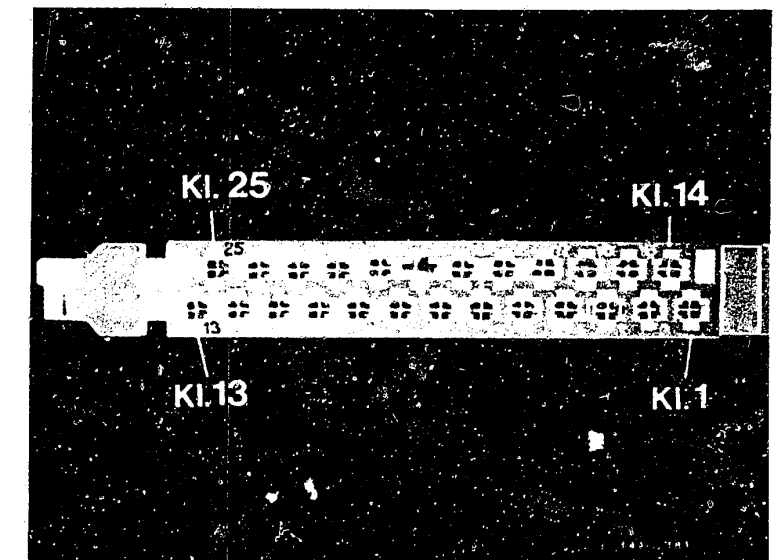
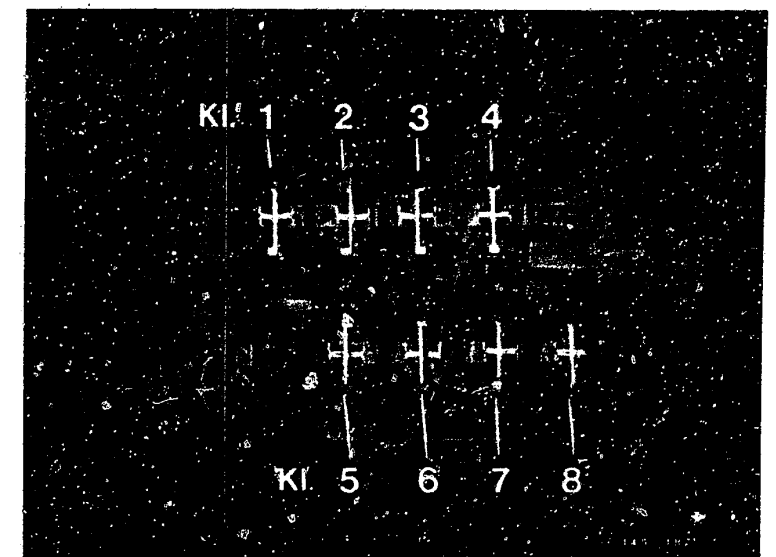
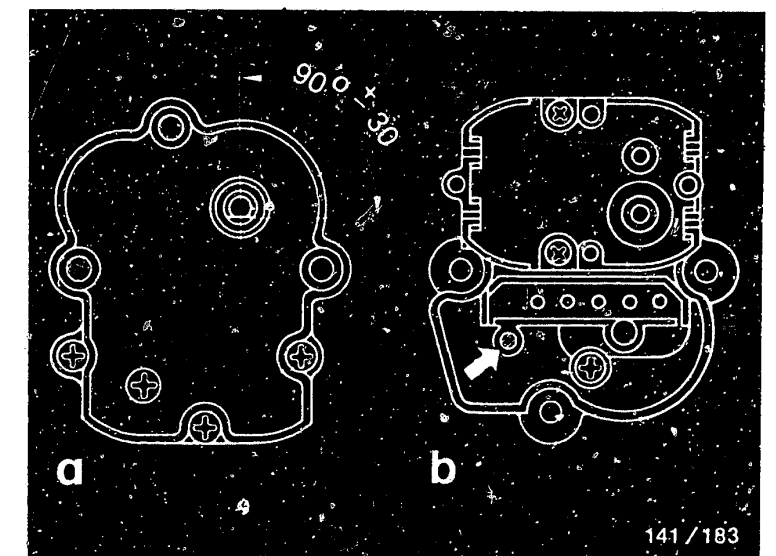
- from control unit plug term. 5 (see top picture) to plug of flap control unit term. 2 (see center picture)

If, when removed, motor of air distributor flap drive was operated, check adjustment of feedback potentiometer. To do this, let motor run to position shown, see bottom picture "a".

Apply 13 V voltage source to plug of flap control unit term. 6 (+) and term. 3 (-).

Connect voltmeter to term. 2 and term. 3.

Adjust 6.4 ... 6.8 V at potentiometer shaft (see bottom picture "b", arrow).

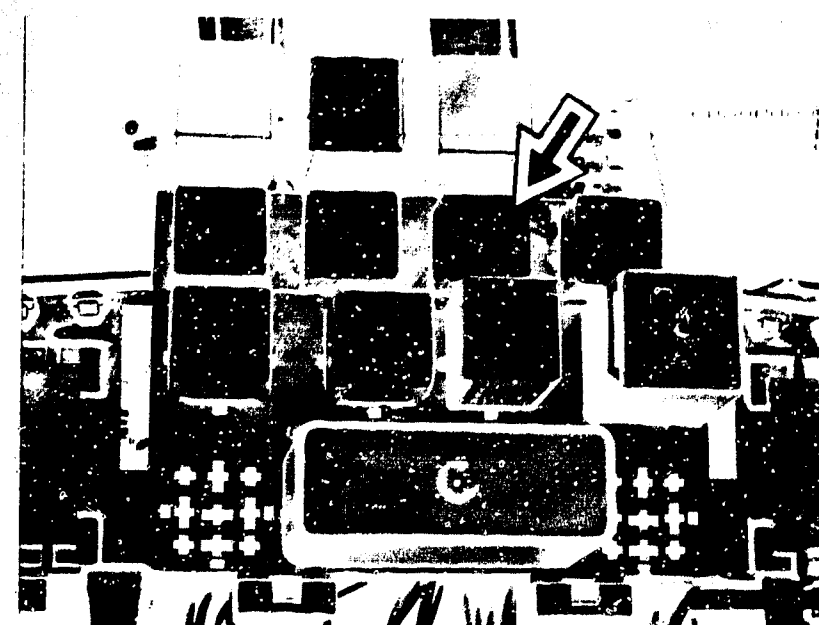
Check relay of refrigerant compressor (see bottom  
picture, arrow) (visual examination: corrosion,  
leads).

Arrow: Refrigerant compressor relay
